# Manhole Inspection Summary

Manhole # S23C1\_007MH

Insp Date: **7/3/08 10:38 AM**

**Location** Address: **2404 Huron St**

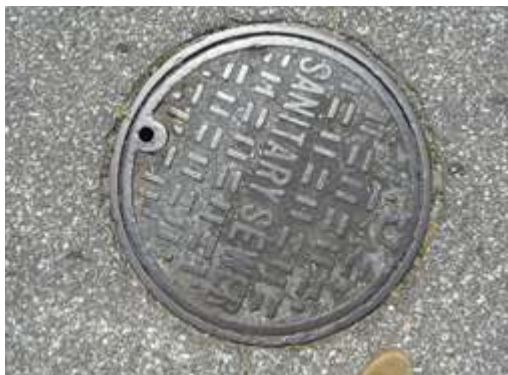
Miscellaneous

lid cover view

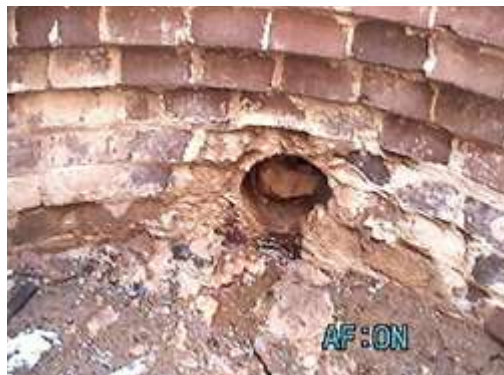
Defect 1

Condition: ☐ Sound ☐ Cracked ☐ Root Intrusion ☐ Deteriorated ☐ Leaks ☒ **Debris**

debris on bench

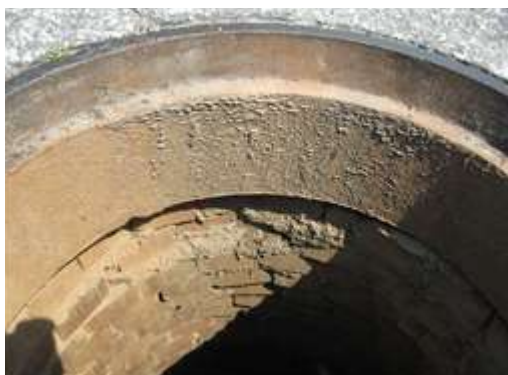
Defect 4

**Frame** Offset: **0** (in.) Condition: ☐ Sound ☐ Cracked ☒ **Leaks**

Condition: ☐ Sound ☐ Cracked ☐ Root Intrusion ☐ Loose Brick ☒ **Deteriorated**

lid-frame infiltration, deteriorating chimney

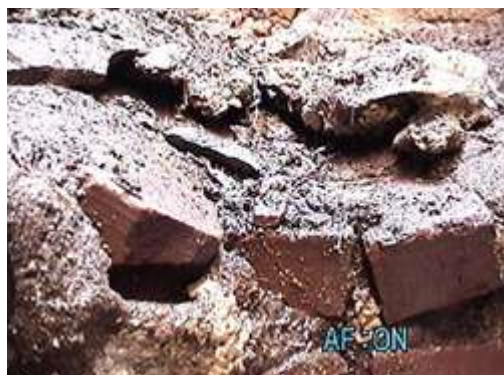
Defect 2

Condition: ☐ Sound ☐ Cracked ☐ Root Intrusion ☐ Deteriorated ☐ Leaks ☒ **Debris**

6 oclk channel blocked; full debris

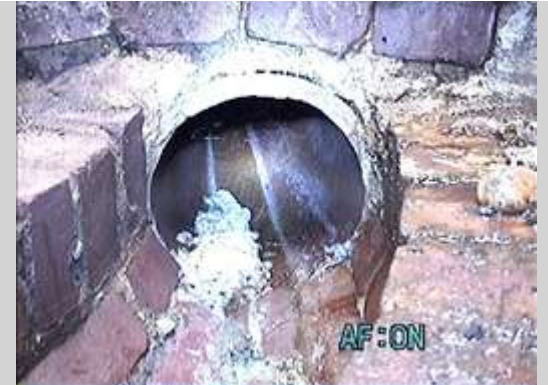
12 O'Clock Outflow

Pipe Height: **8.4** (in.) Rod and Bar (Angled)  
Pipe Material: **Clay** ☐ Pipe Lined  
Invert Depth: **6.72** (ft.) Flow Characteristics: **Slow**  
Deposits: ☒ None ☐ Mud ☐ Sludge ☐ Debris ☐ Grease  
Silt Depth: **0** (in.) Deposits Extent:  
Infiltration: **None** Pipe Seal Cond: **Sound**

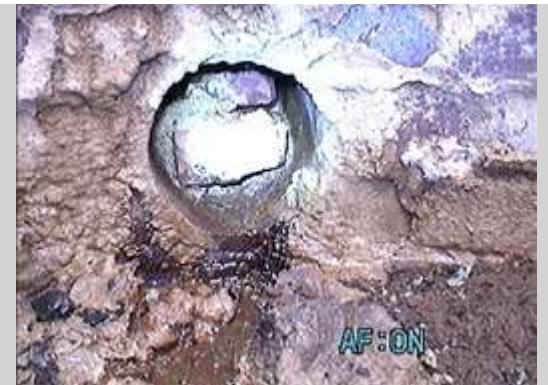
6 O'Clock Inflow

Pipe Height: **6** (in.) Rod and Bar (Angled)  
Pipe Material: **Clay** ☐ Pipe Lined  
Invert Depth: **5.71** (ft.) Flow Characteristics: **Slow**  
Deposits: ☐ None ☐ Mud ☐ Sludge ☒ **Debris** ☐ Grease  
Silt Depth: **4** (in.) Deposits Extent: **Heavy**  
Infiltration: **None** Pipe Seal Cond: **Sound**

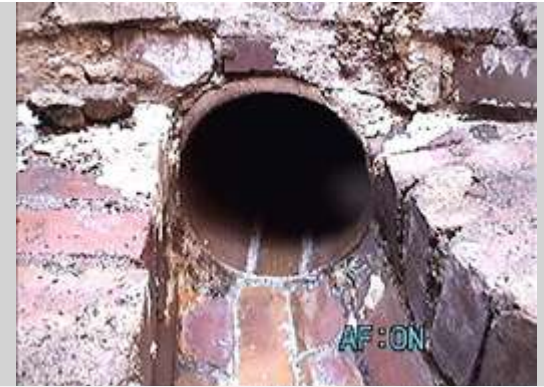
9 O'Clock Inflow

Pipe Height: **8.4** (in.) Rod and Bar (Angled)

Invert Depth: **6.64** (ft.) Flow Characteristics: **Slow**

Deposits: ☒ None ☐ Mud ☐ Sludge ☐ Debris ☐ Grease
